Reducing chronic disease among Lancaster County residents

WALK AUDIT BACKGROUND

Elizabethtown Borough, located in the western portion of Lancaster County, is composed primarily of areas of relatively dense residential areas with pockets of industrial uses and large institutional uses such as Elizabethtown College and the Elizabethtown Area School District. The walk audit was performed within a wide variety of uses including residential, institutional, open space, industrial and mixed use.

The walk audit occurred on March 28, 2014. In attendance were representatives from Elizabethtown Borough Township, Lighten Up Lancaster County, LiveWell Lancaster County, Elizabethtown College, the Lancaster County Planning Commission and local engineering firm, C.S. Davidson, as well as interested Borough residents.

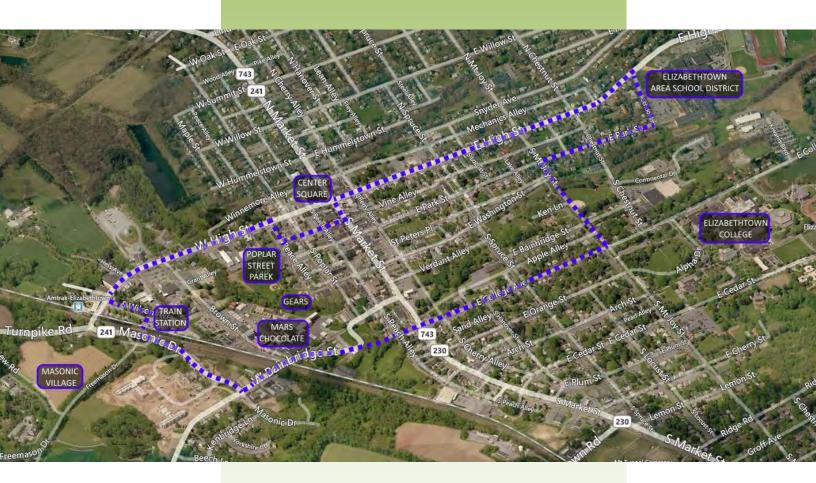
WALK AUDIT ROUTE

The walk audit route was chosen due to the many pedestrian destinations currently located along and near these roadways. Known pedestrian usage confirms that walking is a desirable and useful mode of transportation to these establishments. Starting at the Borough parking lot near Cherry Alley, the walk audit progressed to the Borough center square. The participants travelled east along High Street to the high school and then to the college via School Lane, Park Street and Mount Joy Street. The walk audit route then proceeded west along College Avenue and Bainbridge Street and north along Masonic Drive. A pedestrian tunnel led the group to the Amtrak train station. From there the route travelled east along High Street and along Peach and Rose Alleys before ending at the center square.

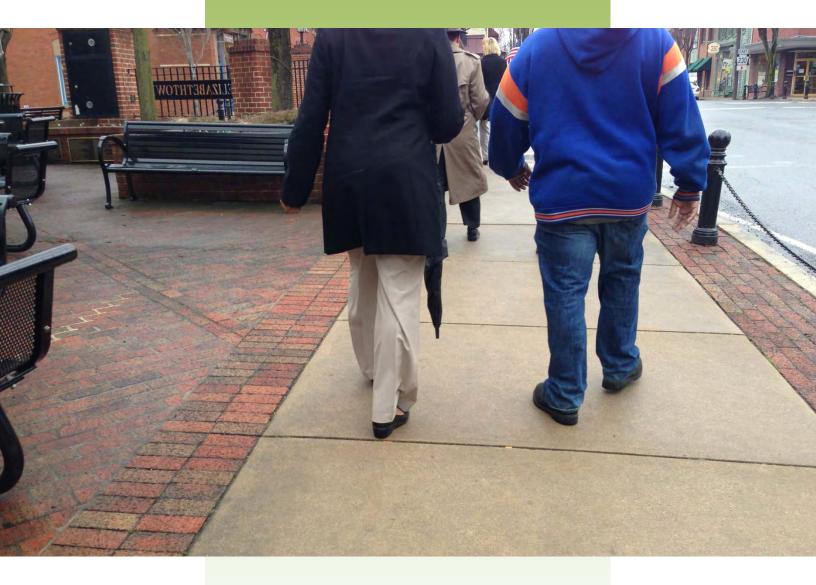
Wide sidewalks at Center Square with attractive brick accents.

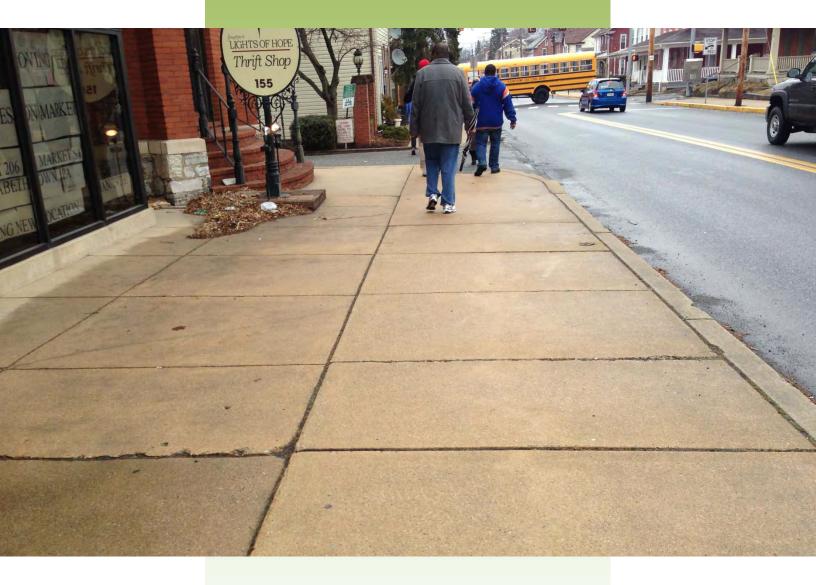
The building facades within the downtown district are close enough to the street to provide an interesting walking environment yet still far enough away from the street to offer plenty of room for pedestrians.

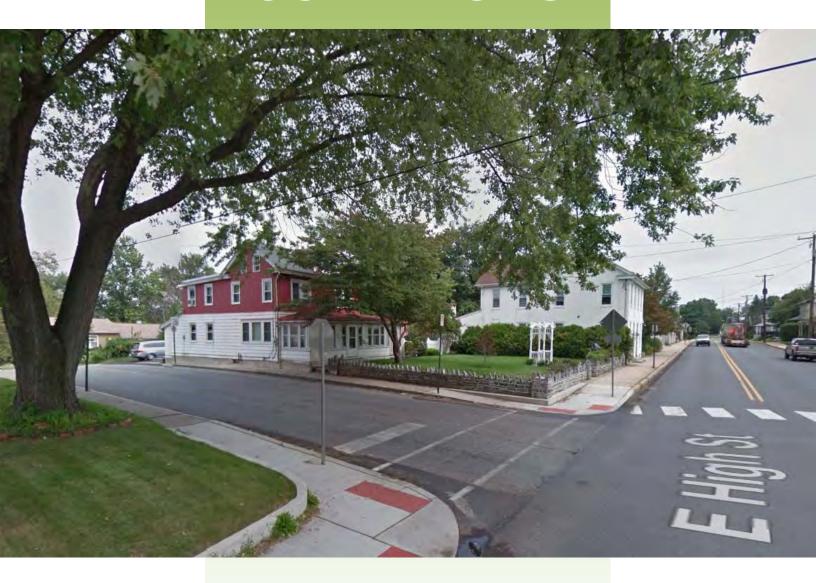
Crosswalks and ADA ramps are provided at most intersections.

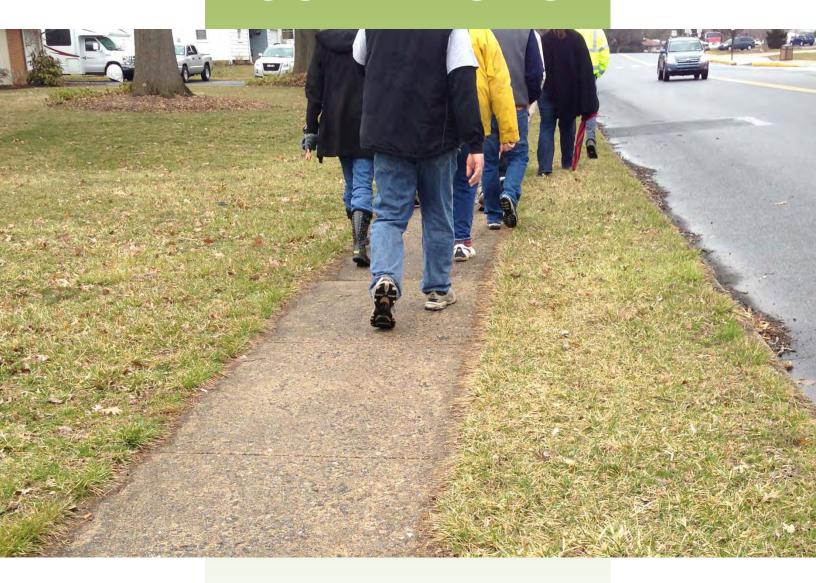
The sidewalk width narrows the further the walk audit route gets from the downtown; however the width is still appropriate for the volume of pedestrian traffic that would be expected in this area.

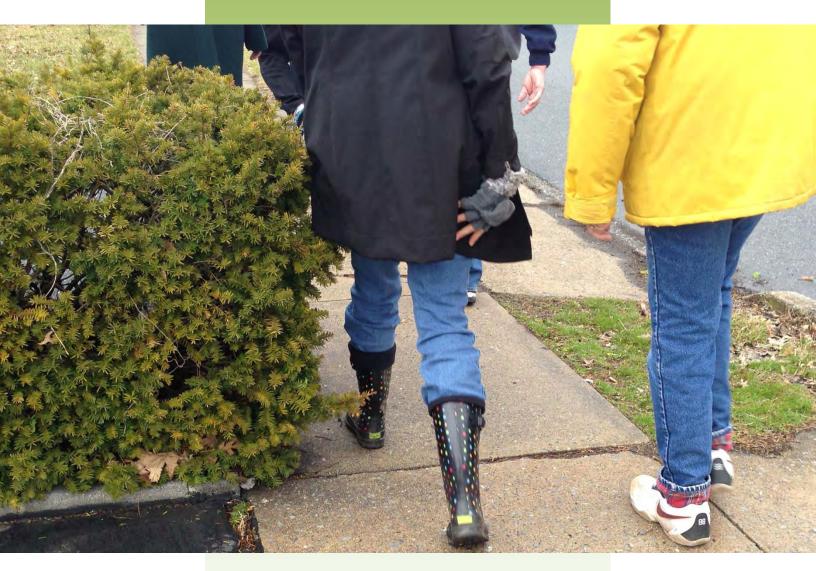
Landscaping protruding into the sidewalk reduces the available walking space at this location.

Any vegetation, including shrubbery and trees, that narrow the sidewalk with can be removed to provide more room for pedestrians.

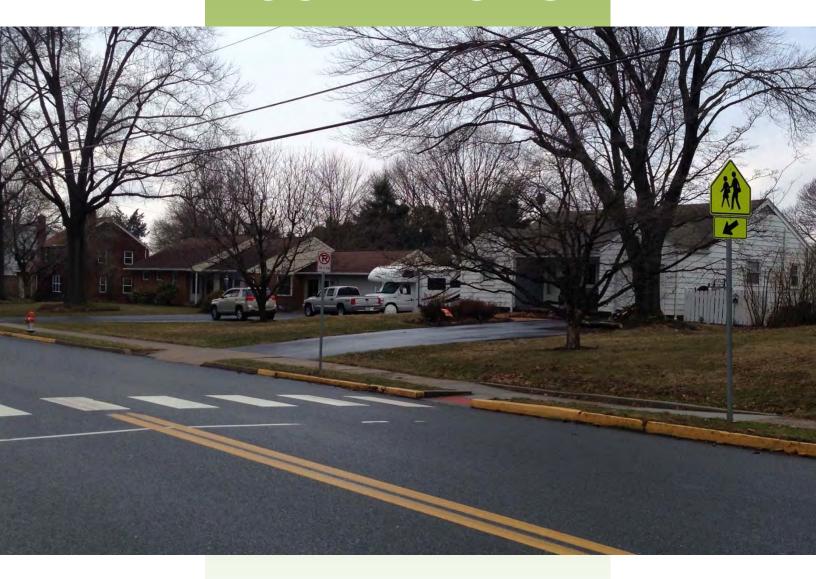
A pedestrian crosswalk and signage is provided across High Street at the Elizabethtown High School.

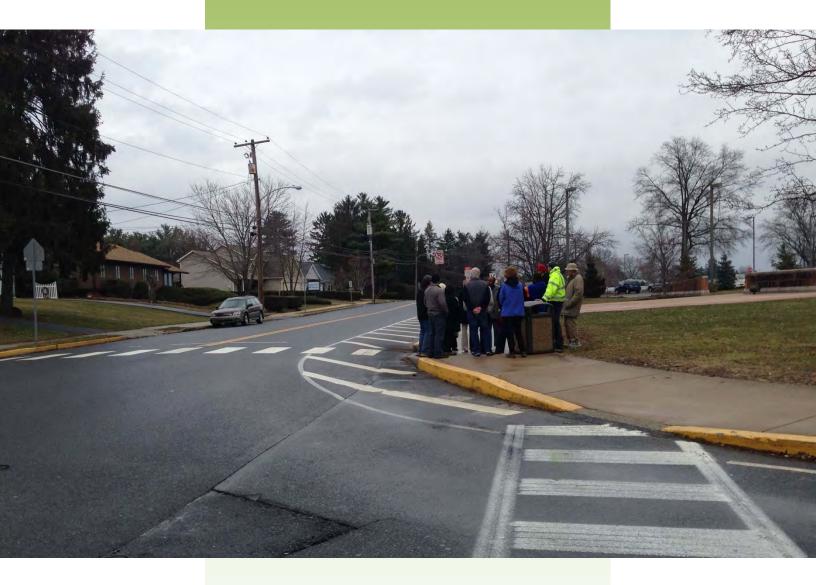
Pedestrian signage is missing at the crosswalk (looking northeast).

Consider adding a pedestrian crosswalk sign at the mid-block crossing at the High School on High Street.

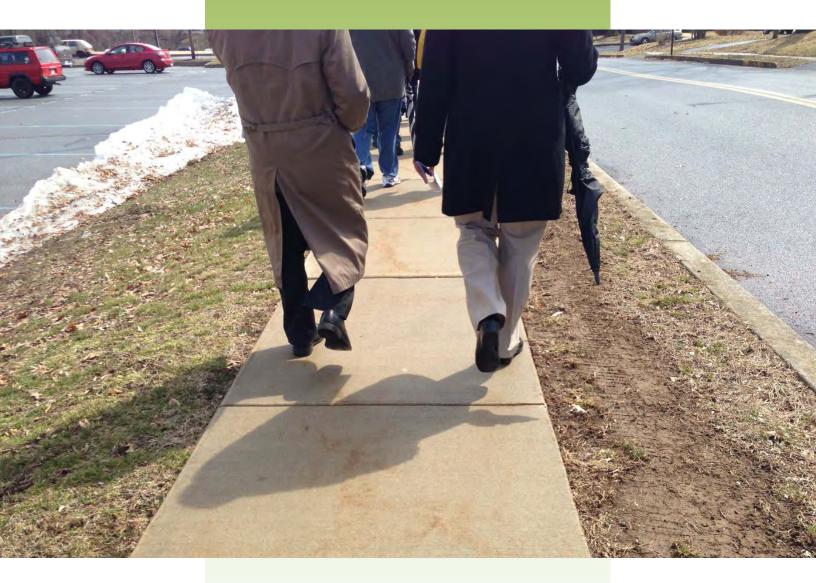
SCHOOL LANE CONDITIONS

Concrete sidewalk is provided with a grass street between the sidewalk and the curb. This strip provides separation from traffic that allows pedestrians to feel safe and comfortable.

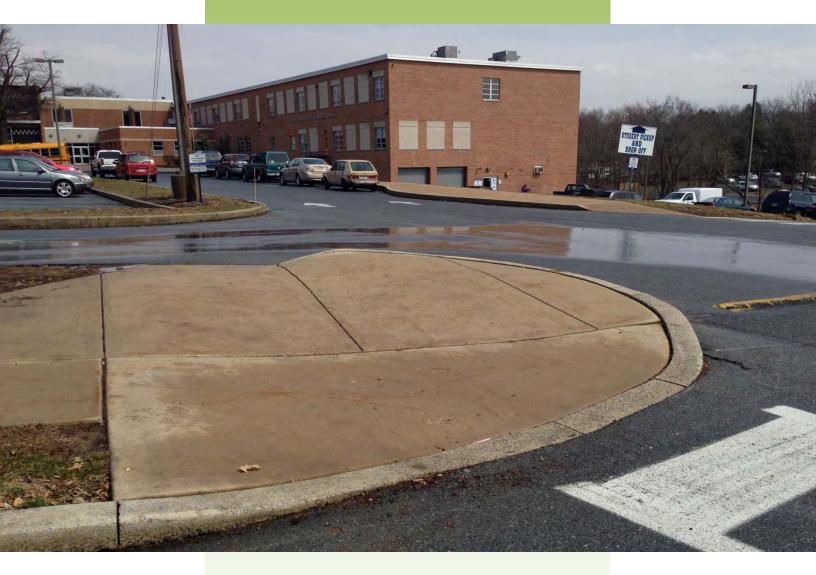
SCHOOL LANE CONDITIONS

Curb ramps are provided at intersections, however they do not meet current ADA standards (eg. no truncated warning dome mat).

Upgrades could be made to curb ramps to meet current ADA standards. Since ramps are required to be upgraded if the roadway is improved, a plan for upgrading curb ramps could be incorporated into a roadway maintenance and/or capital improvement plan.

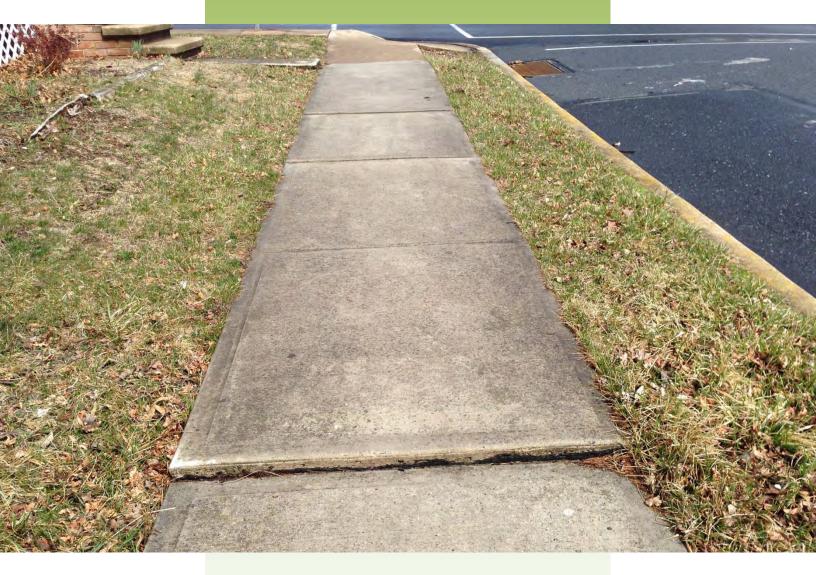
PARK STREET CONDITIONS

A portion of the sidewalk has settled, providing a vertical separation at a joint.

Monitor cracked and broken sidewalks for signs of further deterioration. Initiate repairs if a trip hazard develops due to a vertical separation.

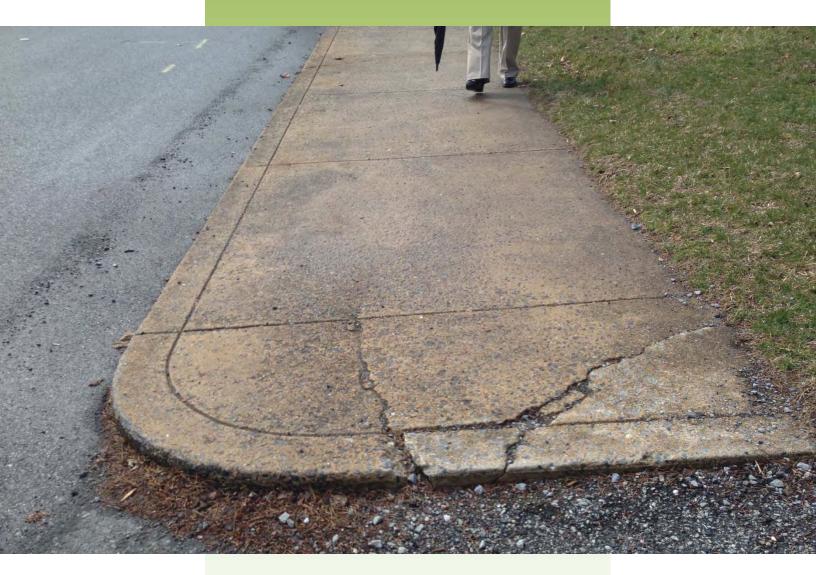
PARK STREET CONDITIONS

Cracked and broken sidewalk is present in some areas.

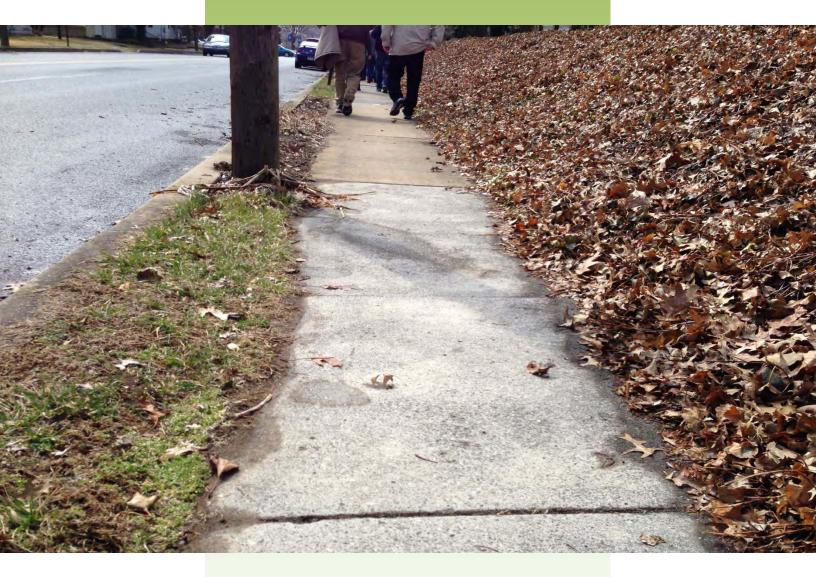
Vegetation encroaches onto the sidewalk, narrowing the travel width slightly.

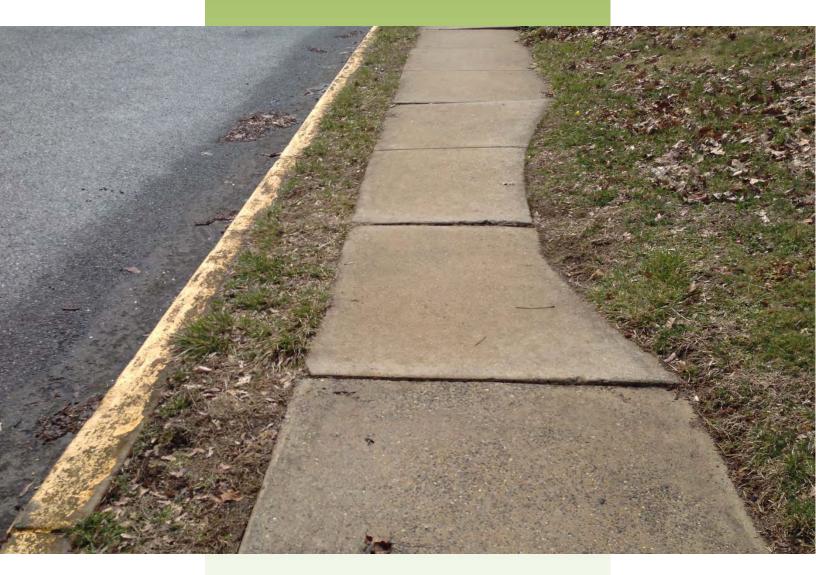
Narrow sidewalk width – possibly due to landscaping or a tree that has since been removed.

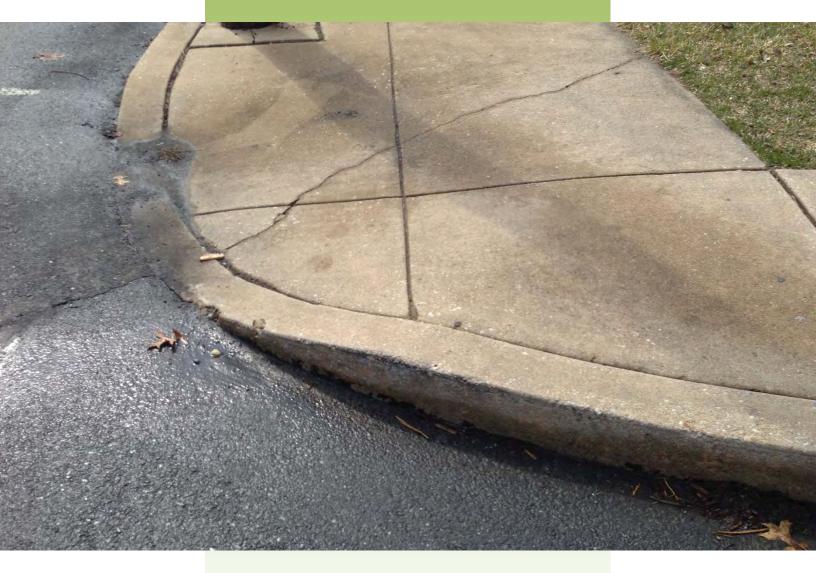
Outdated ADA ramp at the intersection of College Avenue and Spruce Street.

Curb ramps that do not meet the frequently updated ADA standards are typical conditions in many municipalities. The presence of silt buildup and moisture indicate that water ponds at the ramp.

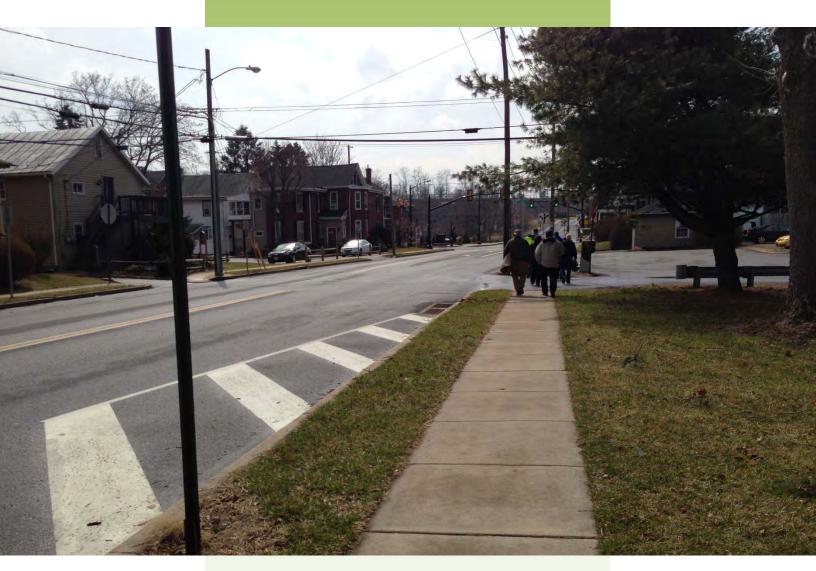
Concrete sidewalks are generally in good condition. The presence of the grass strip and trees make this a comfortable walking route for pedestrians.

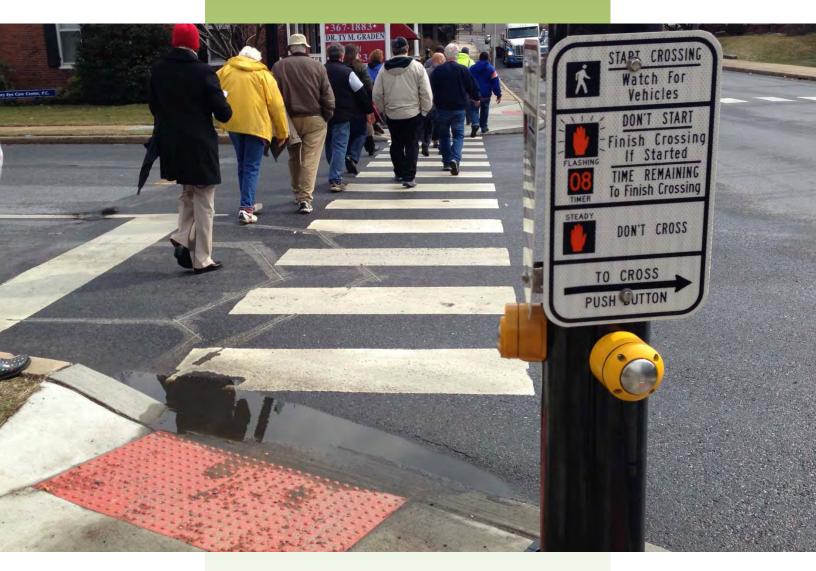
Pedestrian crosswalks, ADA ramps, pedestrian signals and push buttons are provided at the Market Street intersection. Note the water ponding at the ADA ramp. This is not unusual to find at even newly designed and constructed ramps.

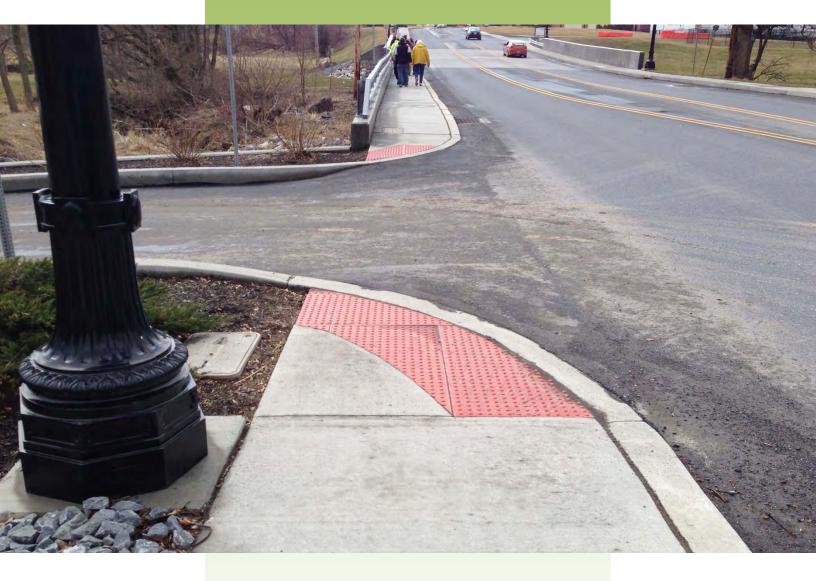
Updated ADA accessible curb ramps, sidewalks and safety features are provided along most of this section of roadway.

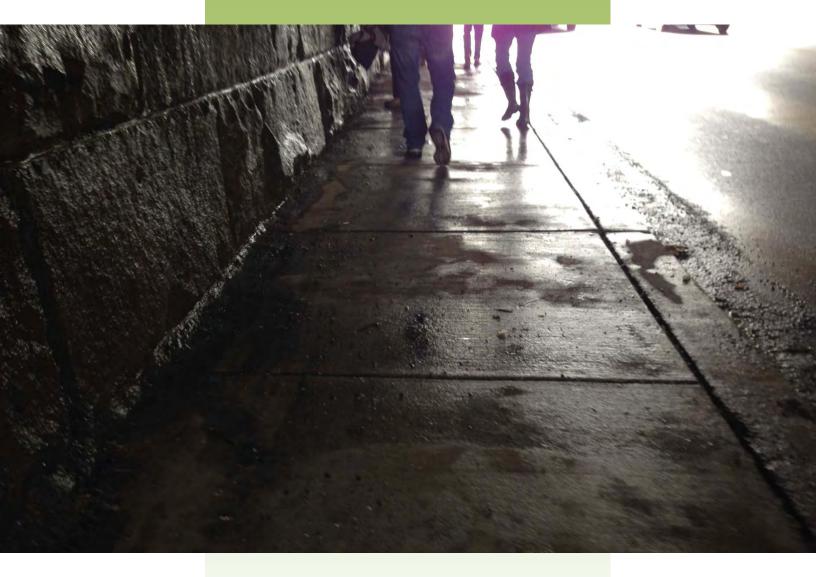
Water is present on the sidewalk inside the Amtrak tunnel. This could cause icy conditions during the winter months.

Consideration could be given to a long-term solution to water infiltration through the Amtrak bridge over Bainbridge Street. Ongoing moisture on the sidewalk could lead to accelerated deterioration of the new sidewalk and/or icy conditions during winter.

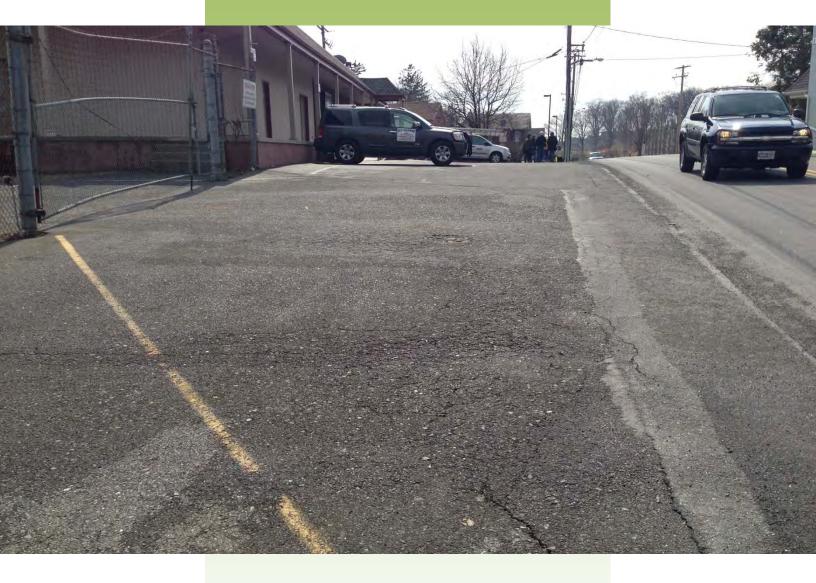
The parking lot of a local business forces pedestrians to cross a long expanse of asphalt unprotected. Fortunately, the volume of traffic entering and exiting the parking lot appeared to be low.

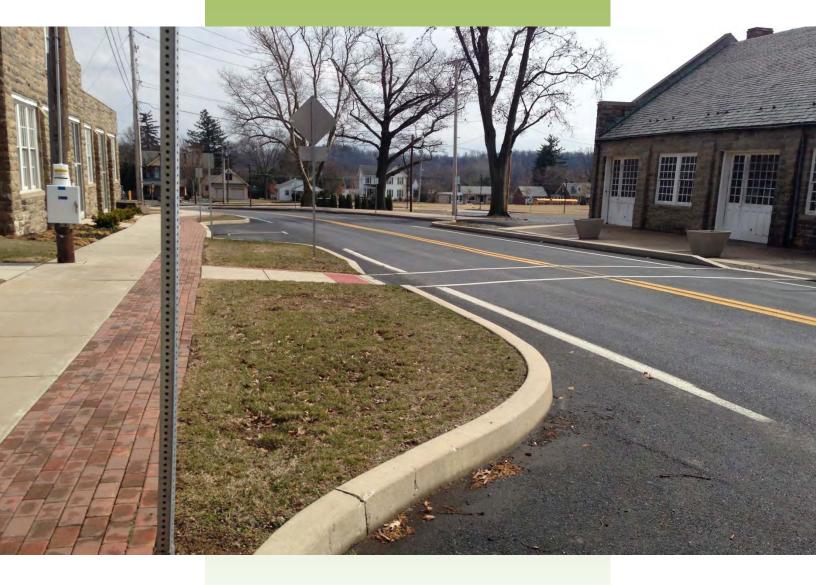
MASONIC DR CONDITIONS

Curb extensiions at a mid-block crossing protect pedestrians waiting to cross and shorten the length of travel needed to cross the travel lanes.

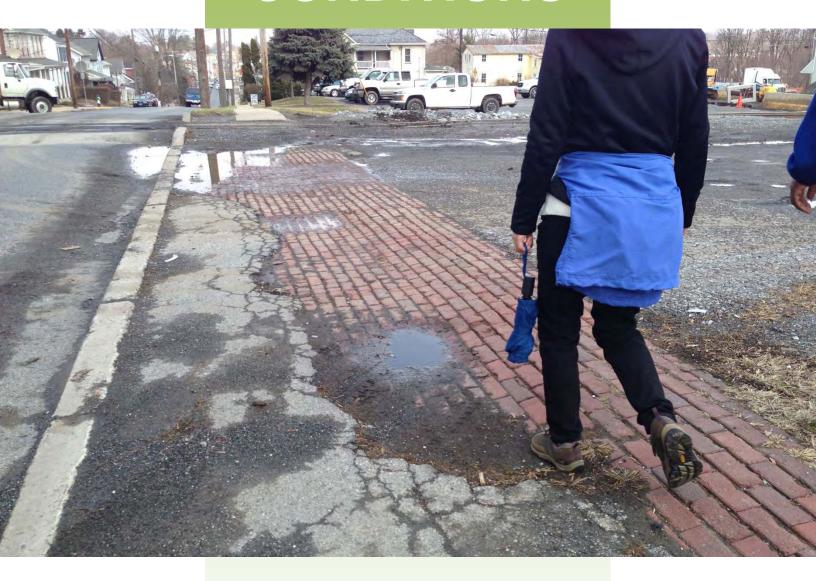
Broken asphalt and uneven bricks are present for a short section near the approach to the railroad tracks.

Sidewalk improvement at the railroad crossing on High Street would increase the walkability of this section. Access to the street could be maintained with the existing depressed curb and a driveway or a grass strip could be provided as shown above. The Borough is currently constructing a dedicated walking path that will run parallel to this section of the walk audit route, providing an alternate route for pedestrians.

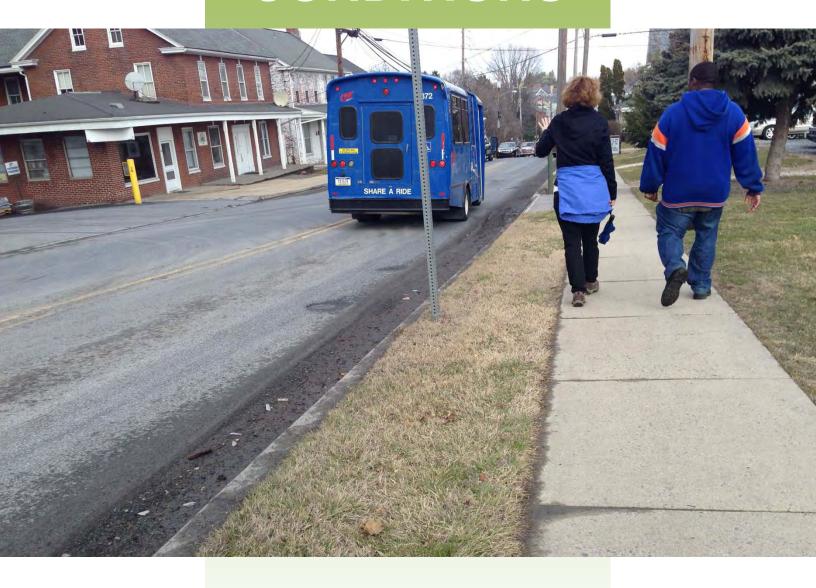
HIGH STREET CONDITIONS

Concrete sidewalks are present for most of High Street and are largely in satisfactory condition.

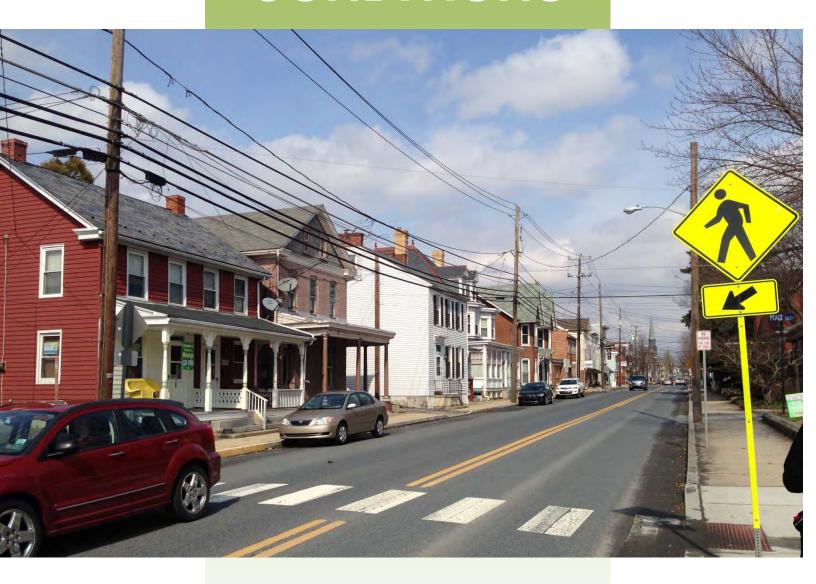
HIGH STREET CONDITIONS

Pedestrian crosswalks and signage are prevalent throughout the Borough.

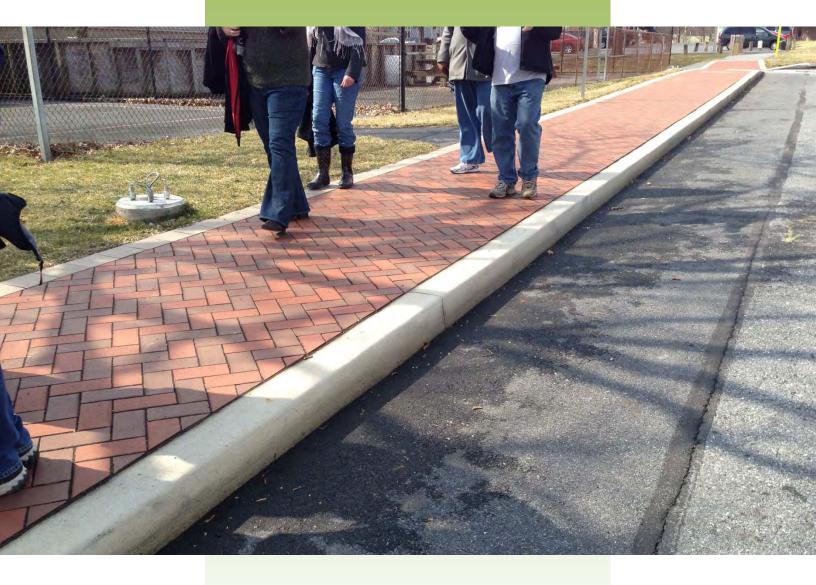
ROSE ALLEY CONDITIONS

Decorative brick pavers provide an attractive walking surface.

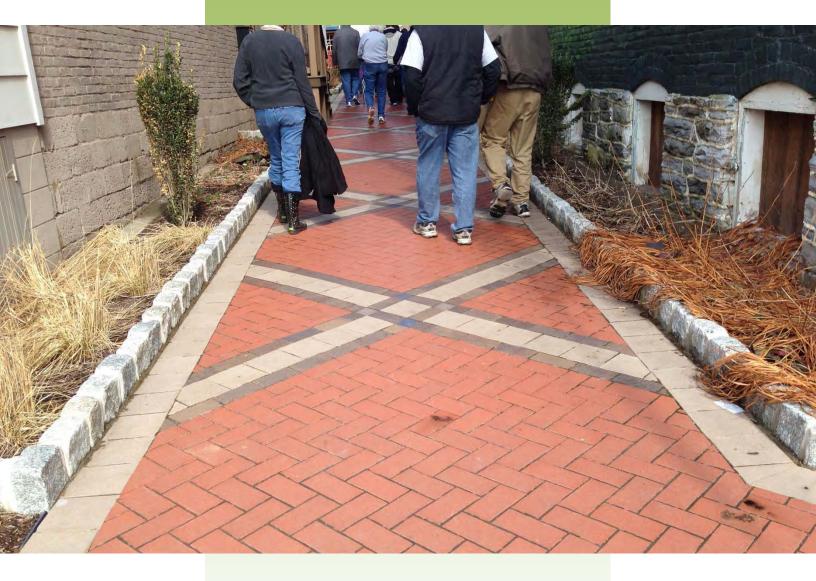
ROSE ALLEY CONDITIONS

Luminescent pavers inlaid between the standard brick pavers provide pedestrian lighting during nighttime hours.

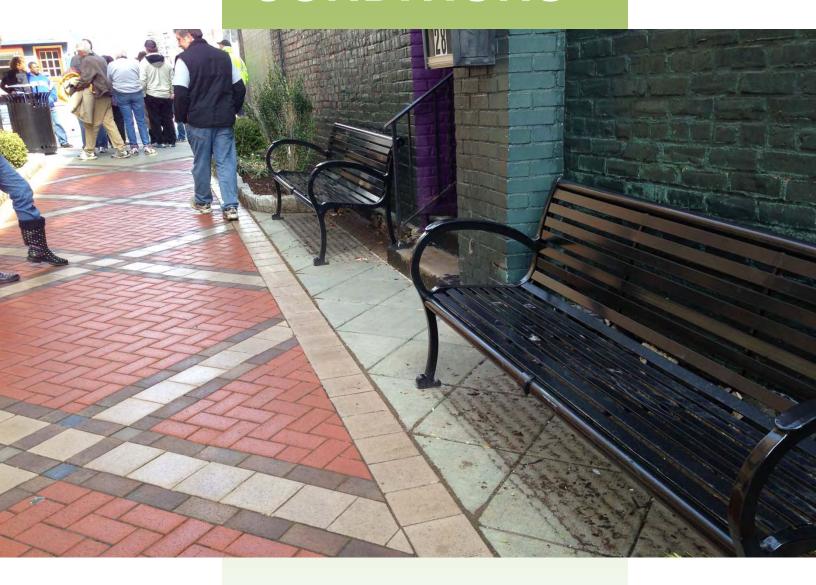
ROSE ALLEY CONDITIONS

Often considered an amenity, benches can be a necessity for the elderly and pedestrians with young children who need to stop and rest.
